Manhole Inspection Summary

Manhole # S25SS1006MH

Insp Date: **6/1/07 2:32 PM**

Location Address: **CARLOWE RD**

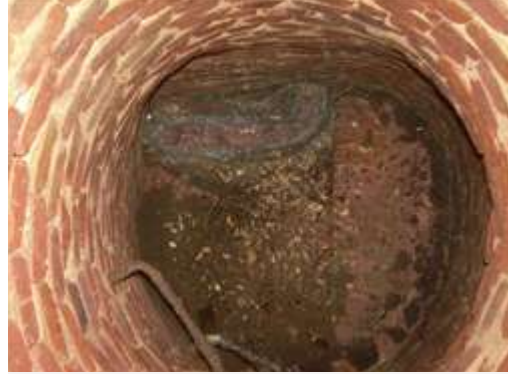
Top View

Barrel infiltration. Corroded and missing steps. Bench debris.

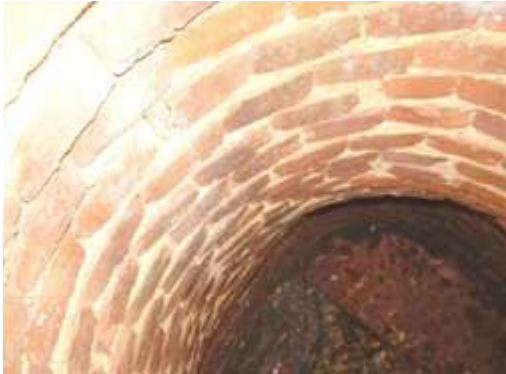
Defect

Adjustment infiltration.

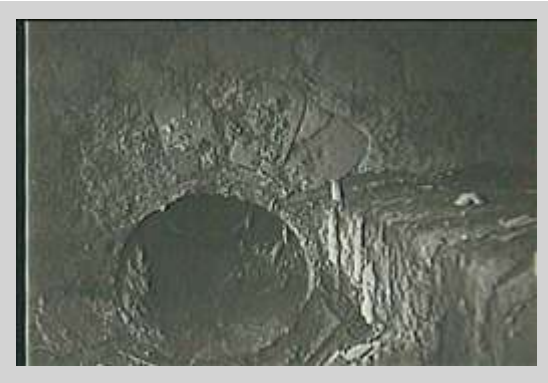
8 in. Circular Gravity Sewer Pipe Out @ 12 O'Clock

Barrel infiltration. Channel deterioration.

Deposits: ☐ None ☐ Mud ☐ Sludge ☐ Debris ☒ Grease

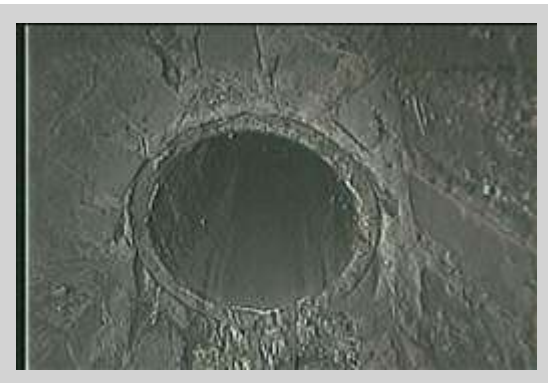
8 in. Circular Gravity Sewer Pipe In @ 9 O'Clock

Infiltration: **Evidence** Pipe Seal Cond: **Unknown**
